Seismic Vulnerability Reduction of Historical Masonry Towers by External Prestressing Devices

Dissertation

Adolfo Preciado Quiroz
Born 16 October 1977
from Colima, Mexico

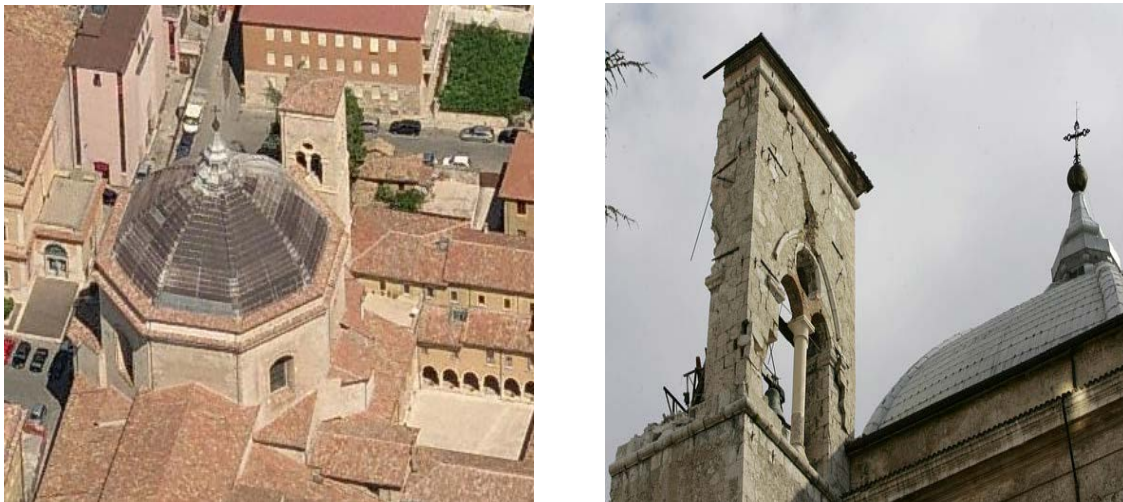
Figure 1.2: San Bernardino church undamaged and observed damage after the 6.3 magnitude earthquake of L'Aquila, Italy on April 6th, 2009 [Bazrafshan, 2009]

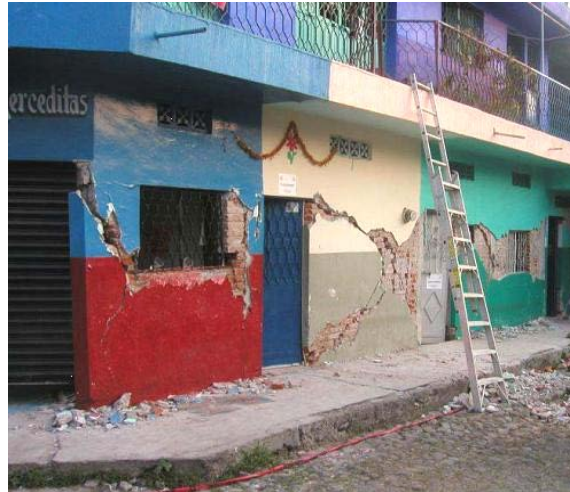
Figure 2.13: Typical shear failure mode observed in unreinforced masonry walls after the 7.5 magnitude earthquake of Colima, Mexico in January 2003 [SMIS and EERI, 2006]

The most important failure mode observed in unreinforced masonry walls subjected to alternated horizontal in-plane inertia loading corresponds to a diagonal double cracking as shown in Figure 2.13. When the size of these cracks is excessive, it generates a state of rapid stiffness degradation that could lead to a brittle collapse of the structure. Shear failure is presented in unreinforced masonry buildings when there is not enough density of walls in one of the plan directions X or Y, or by the presence of excessive openings (failure points) that substantially reduce the resistant area and generate the concentration of stresses. Therefore is commonly observed after a considerable earthquake the presence of large diagonal cracking at the corners of openings or at the complete wall as depicted in Figure 2.13. Sperbeck [2009] affirms that there are many influencing parameters on the failure mechanisms of in-plane loaded masonry walls. The most important ones correspond to the vertical load level, slenderness, support conditions in terms of top rotation (constrained or free) and material parameters.

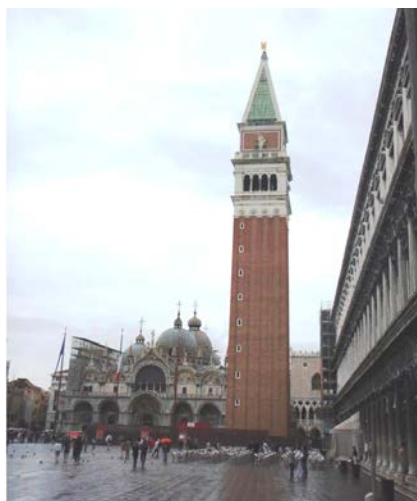
Figure 2.19: Replica of the collapsed bell tower of “Piazza San Marco” in Venice, Italy

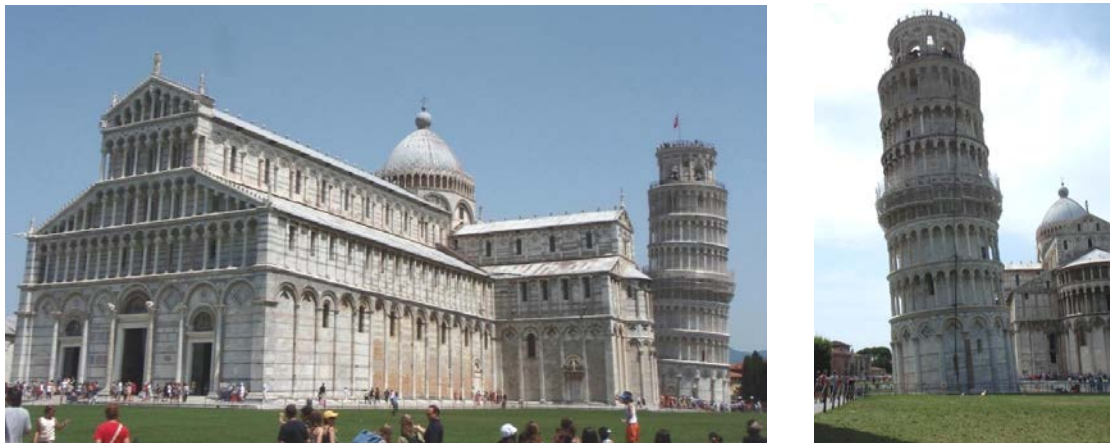
Figure 2.20: General view of the leaning tower of Pisa, Italy

the epicenter. These low frequencies mainly affect slender structures like masonry towers because their fundamental vibration frequency is in the range of the predominant frequency of the ground motion (resonance phenomena). The high mass of the tower and flexibility due to its slenderness generate that the structure presents during an earthquake important top displacements. By the other hand, high frequencies and low periods mainly affect compact structures like most of the historical buildings. *Liquefaction* due to ground motion and instability conditions by *soil settlements* are geotechnical issues that depend on the site. The latter issue has been observed at the Metropolitan Cathedral of Mexico City since decades due to soft soil conditions. The most famous case presented in historical masonry towers is the leaning tower of Pisa, Italy. Since its construction in the XII century it started to incline, due to irregularities in the soil conditions, being with this quite vulnerable to overturning (see Fig. 2.20).

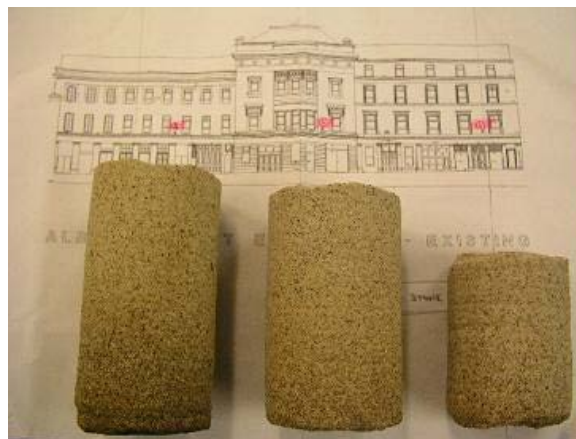
Figure 3.1: Extracted cores of the façade of an historical masonry building [BGS, 2009]

extraction of the different structural elements (Fig. 3.1) with the use of modern drilling equipment. Afterwards, from this internal sampling several test-tubes are extracted in laboratory to obtain by compression loading the stress-strain curve, and from this, to determine the mechanical parameters of masonry. Meli [1998] affirms that these laboratory tests may be inaccurate and less representative when the type of masonry of the structural element is either irregular or three layers masonry, and in this case, these tests are only helpful for material identification of units and mortars. More representative results could be obtained by the in-situ application of the double flat-jack test as depicted in Figure 3.2.

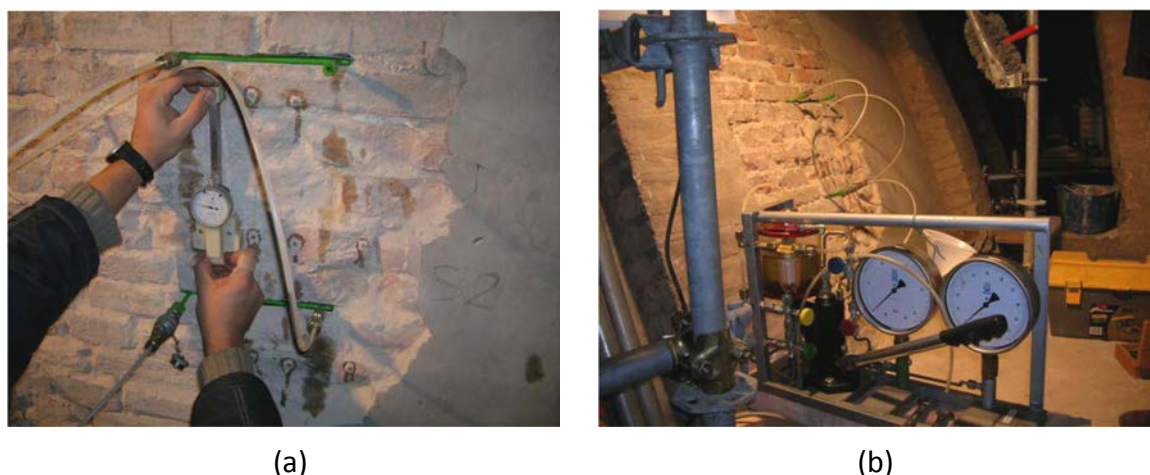
Figure 3.2: In-situ testing by double flat-jack in a historical masonry dome (Cathedral of Siena, Italy); (a) base distance measurement and (b) overall view [Bartoli et al., 2008]

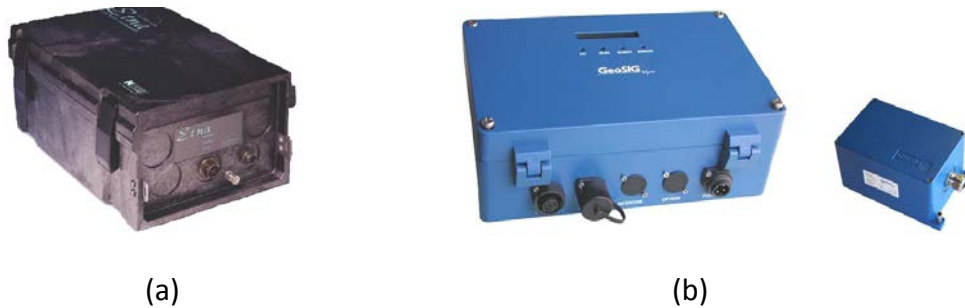
Figure 3.4: Two types of classic accelerometers for the dynamic characterizations

obtain quantitative information of the natural frequencies and vibration modes. Araiza [2003] recommends that the selection of the equipment has to be based on factors such as economy, simplicity and effectiveness. These devices (Fig. 3.4) measure in a certain period of time the vibration of the structure when excited by ambient vibration such as wind or traffic, and in seismic zones by micro-seismicity. Rarely real earthquakes are recorded during these short experimental campaigns, at least that a permanent network of accelerometers has been installed and monitored in the building.

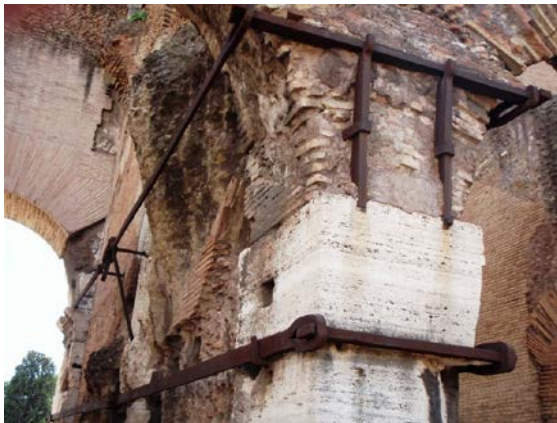
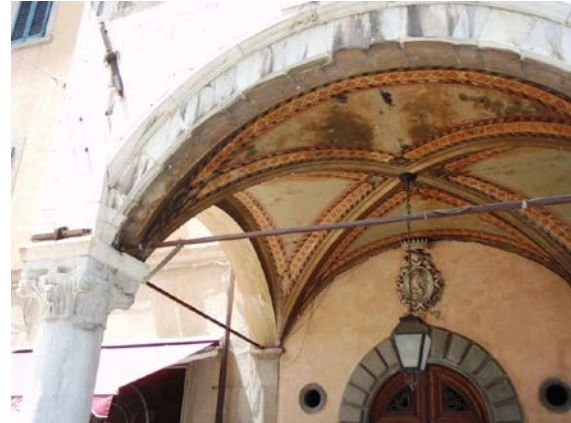
*Figure 3.11: Presence of old prestressing in Italian historical monuments;
(a) the Roman Coliseum and (b) vaulted structure in Pisa*

Prestressing of masonry structures is not a recent retrofitting technique as it could be observed quite often in existing ancient masonry buildings in Italy (Fig. 3.11). Croci and D'Ayala [1993] and Croci [1995] affirm that past interventions were developed in the Roman Coliseum at the beginning of the XIX century to connect the internal walls

perpendicularly located to the external ring of the monument, in order to protect them against out-of-plane loading that could cause their overturning (see Fig. 3.11a). The addition of different types of metal bars (also named chains, belts and ties) was a common practice in past interventions of old constructions. Figure 3.12 shows several types of metal bars with their anchorages and tighteners of the same material. In order to generate the effect of prestressing the metal tie was usually heated to expand the material and when it returned to its normal temperature by means of the contraction, a shortening was generated, producing with this the active prestressing force. Throughout the history, the most frequent uses of old prestressing in ancient structures have been to tight and to connect walls to prevent overturning and to stabilize arches, vaults and cupolas that were damaged or identified as instable for an excess of opening or movement of their supports due to seismic forces (Fig. 3.11). The main disadvantages of these old metal bars were their heavy weight and the susceptibility of the material to suffer environmental attack represented by corrosion, reducing its resistance and damaging masonry by the volumetric change of the corroded bars leading to cracking and staining. Moreover, the difficulties to generate a good connection between bars and the excessive concentration of stresses induced by the anchorage to the masonry could lead to crushing. Another disadvantage was that there was no control or monitoring of the prestressing force, changing throughout the years by temperature, corrosion and by relaxation due to the deformation of masonry (creep).

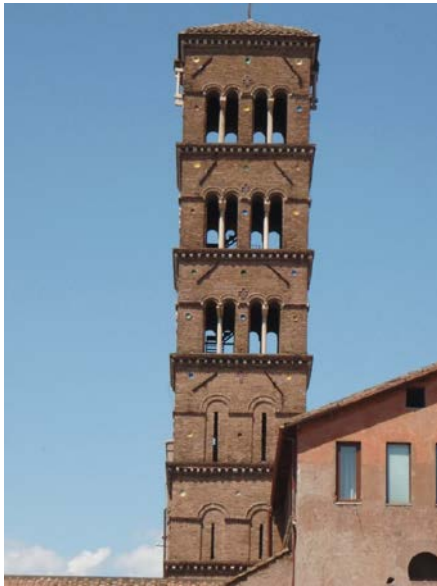
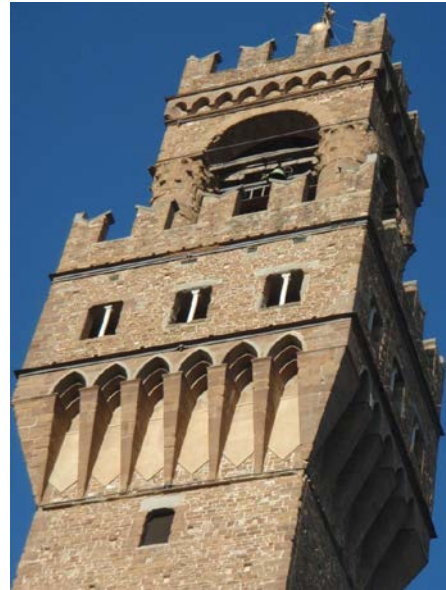
Figure 3.19: Presence of prestressed metal bars in Italian old masonry towers; (a) bell tower at the Roman Palatino and (b) the civic tower of the “palazzo vecchio” in Florence

Past intervention techniques used in ancient masonry towers have been used more as local strengthening of certain vulnerable structural parts than for a real improvement of the global behavior of the structure against earthquakes. This is consequence of the limitations in the existing materials in those periods added to the lack of technology and knowledge about the real behavior of these structural elements (Figs. 3.19 and 3.20).

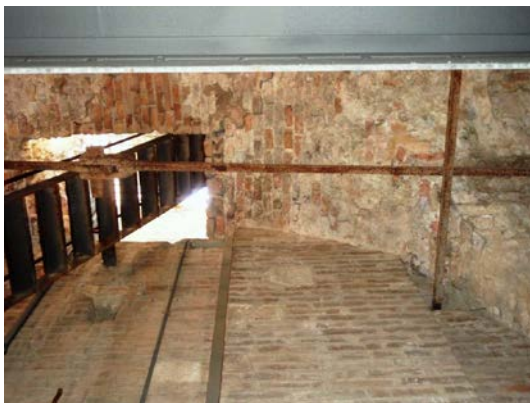
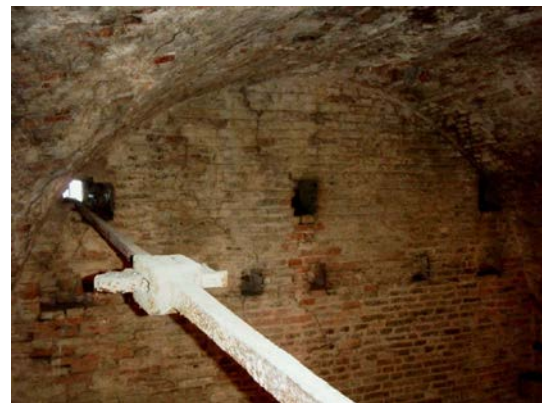
Figure 3.20: Metal bars in the upper internal part of the “Torre Grossa” in San Gimignano

A couple of metal bars of rectangular transversal section were usually applied in horizontal way and in two directions in the internal part of towers, at belfry, in order to generate a better connection between walls in the X and Y direction and to provide with this more stability, and to avoid the out-of-plane collapse of the upper walls in case of the occurrence of an earthquake (Figs. 3.19a and 3.20). By the other hand, the tower of Figure 3.19b presents an application of the metal bars at the perimeter of the upper part of the tower as belts aimed at fastening, to avoid with this the overturning. Figure 3.20 depicts the old prestressing system described in section 3.3.2, including connections between segments, tightener and the anchorage inserted through the wall.

part of the SW edge. About 17 years later, the collapsed part was re-constructed. Nowadays, the tower presents important vertical cracks (Fig. 6.20a) related to long-term heavy loads and the lightning, and moreover localized damage due to grenade shots during the Second World War. In the present research, several technical visits were developed to assess by visual inspections and photographic survey the actual conservation state of the building (Fig. 6.19a). Despite of the ancientness of the tower, it presents a good conservation state and is open to the public. Only at the South façade, the presence of invasive vegetation was observed. This could lead to the generation of new cracks or the extension of existing ones (Fig. 6.19b). Moreover, the presence of old metal chains was identified at the internal upper part of the tower (Fig. 3.20).

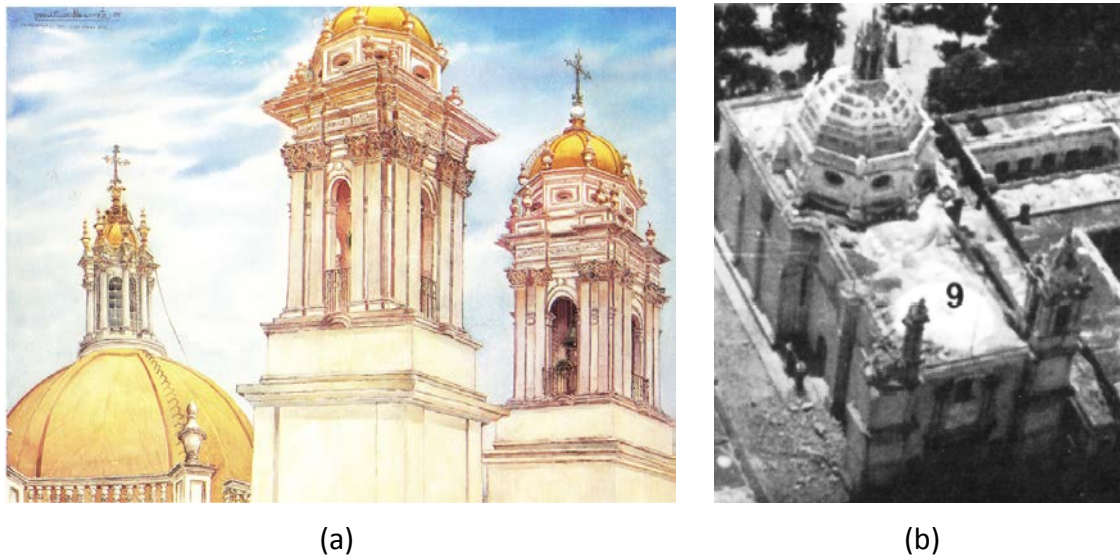
Figure 6.6: The Cathedral of Colima, Mexico; (a) view of the two towers and the cupola [Guzman et al., 1986] and (b) observed damage after the 1941 earthquake [Zobin, 2004]

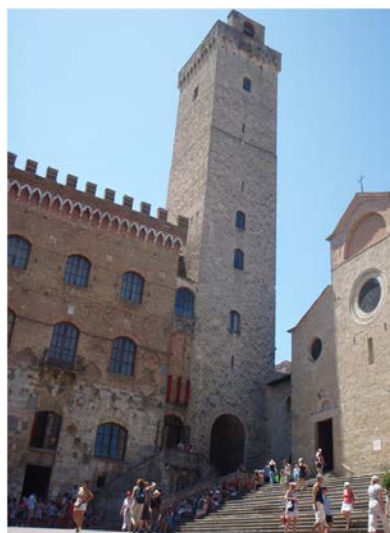
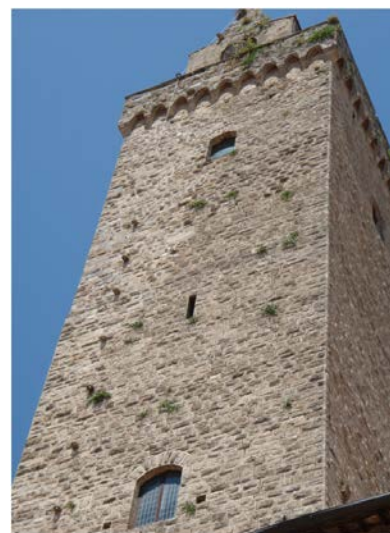
Figure 6.19: The medieval tower (Torre Grossa) of San Gimignano, Italy; (a) general view and (b) presence of vegetation on the South façade

Bartoli et al. [2000] and [2006] describe that the “Torre Grossa” was approximately built in the XIII century and is the tallest and most important among the preserved towers in the town of San Gimignano. Its cross section is square with dimensions of 9.5 x 9.5 m and a total height of about 60 m with walls of variable thickness (2.6-1.6 m). The walls are made of three layers masonry (*sacco*). The external layer is constituted by stone and mortar, the internal by brick and mortar and the filling by remains of bricks in a matrix of poor mortar. At the height of 20 m the tower is incorporated to the neighbor Town Hall (*Palazzo Comunale*) previously constructed. The floors were built with vaults of brick masonry. An internal steel stair permits to reach the top of the tower (RC slab).
